REPORT OF INVESTIGATIONS/1989

Field Evaluation of Three Longwall Pillar Systems in a Kentucky Coal Mine

By Timothy M. Barton and Christopher Mark

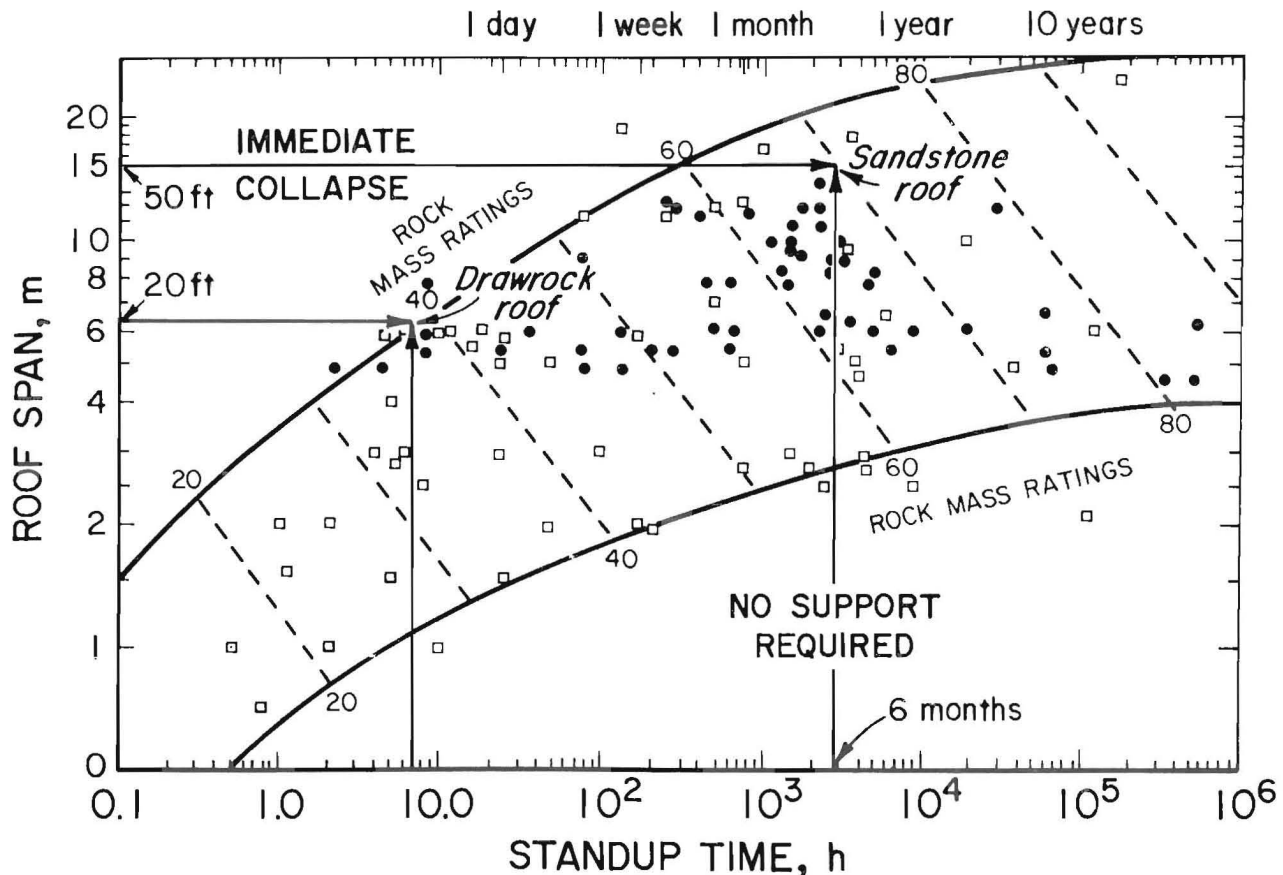
Figure 2.—Back calculation of RMR for drawrock and sandstone roof of Scotia Mine using chart presented by Bieniawski.

The Rock Mass Rating (RMR) (8) of the Scotia Mine roof was determined by back calculation. Several locations were observed in which 20-ft spans of thick-shale drawrock had collapsed within hours after they were mined. Using Bieniawski's chart (fig. 2), the RMR for the drawrock roof was estimated at 39. Few falls of the

sandstone roof occurred, but in one instance an intersection with a large effective span collapsed 6 months after it had been mined. Again using figure 2, the RMR of the sandstone may be estimated at 70.

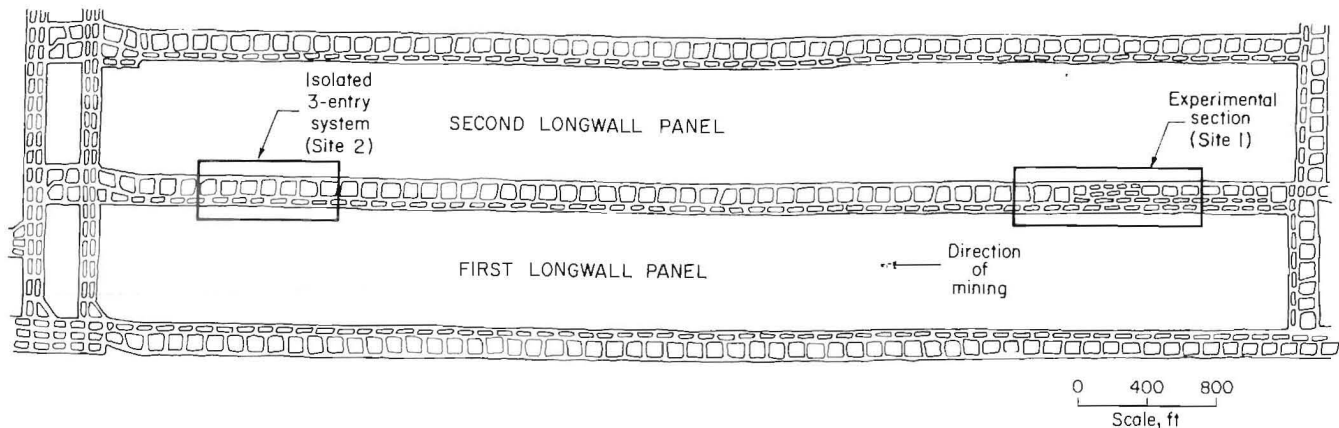
Figure 3.—Location of site 1 and 2 in gate road of first panel in deep-cover reserve area.

Longwall mining has now moved to a large area of reserves located under much greater cover. A series of panels, each measuring 700 ft wide by 7,000 ft long, will be mined in sequence. Initial plans called for the use of the same yield-abutment pillar design, with three entries on 48- and 120-ft centers, in the new panels. In addition, mine management decided to use the inby portion of the headgate of the first panel as a testing ground for two new pillar designs (fig. 3). Beginning 1,300 ft outby the setup room, a 400-ft length of the gate system was driven as an all-yield pillar system, with five entries on 48-, 40-, 40-, and 40-ft centers. Then one of the new entries was dropped for the remaining 900 ft, leaving a yield-yield-abutment pillar system with four entries on 48-, 40-, and 80-ft centers. The experimental section (site 1) that was monitored by the Bureau included the entire five-entry system and several breakthroughs of the adjacent three-entry and four-entry systems. In addition, a second site (site 2) consisting of 800 ft of the standard three-entry design was monitored approximately 4,000 ft outby the experimental section as seen in figure 3. The second site was chosen so that the three-entry system could be studied in an area free from possible interaction with the yield pillar area.

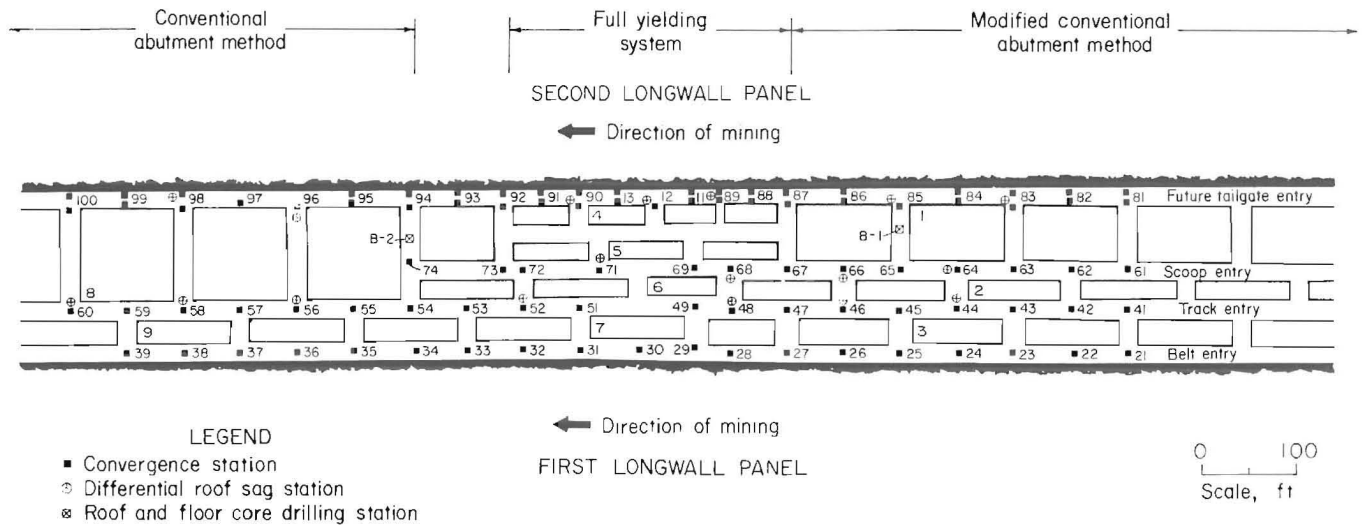
Figure 4.—Map of site 1, showing convergence stations, roof sag stations, and core drilling locations.

At site 1, the measurement stations were installed shortly before the startup of the longwall face. Convergence stations were installed in the belt, track, and scoop entries at approximately 60-ft intervals (fig. 4). Two rows of convergence stations were installed in the future tailgate entry of the second longwall panel. A total of 18 roof sag stations were distributed between the three pillar designs in the experimental section, though none could be installed in the belt entry. The anchors in the differential roof sag stations were installed at depths of approximately 5, 9, 14, and 18 ft above the roofline. The anchors were installed at specific depths so that the 18-ft-high anchor was located above the zone of significant movement, and the other anchors were placed to measure movement in the immediate roof.

Core drilling was conducted at two locations in site 1 as shown in figure 4. Figure 9 shows the geologic logs and the results of laboratory strength tests obtained from the core. The classification of Fern and Weisenfluh (10) was used in characterizing the lithology of the roof and floor. Several facies of sandstone were found in the roof, with compressive strengths ranging from 14,000 to 25,000 psi and elastic moduli averaging 5,000,000 psi. The roof shale obtained at site 2 in the experimental section was found to have an average strength of 15,000 psi and an average

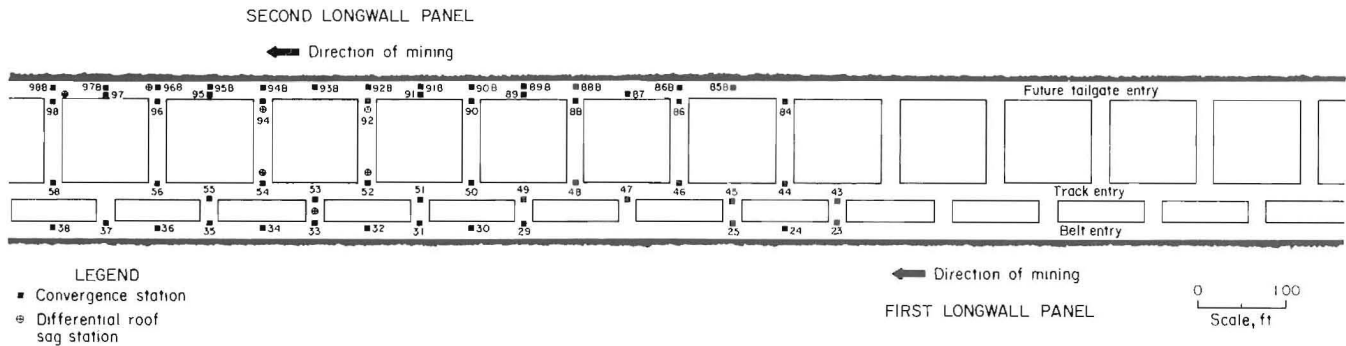
Figure 5.—Map of site 2, showing convergence stations and roof sag stations.

At site 2, the measurement stations were arranged in a pattern similar to site 1 (fig. 5). A total of seven differential roof sag stations and 54 convergence stations were installed. Figure 6 shows Bureau engineers measuring roof sag at the study area (9).

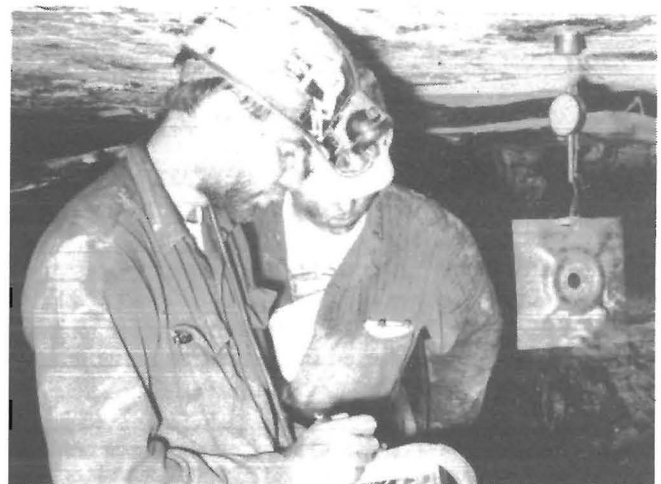
Figure 6.—Bureau engineers measuring roof sag.

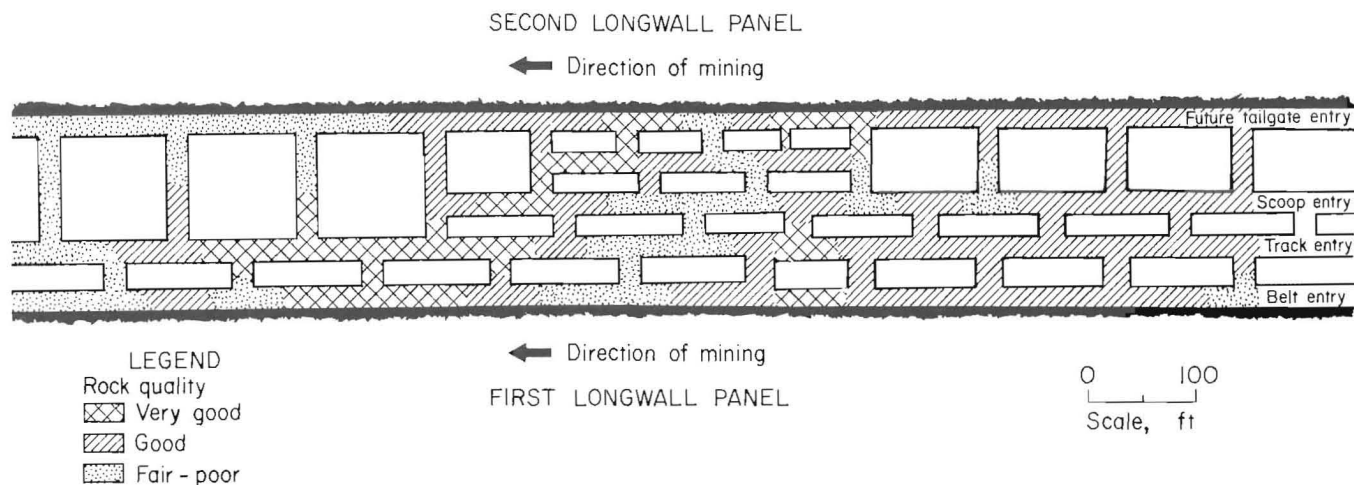
Figure 7.—Map of initial roof quality in site 1.

Figure 7 shows the initial distribution of roof quality over site 1. The fair and poor quality roof (these grades are combined in figure 7) was found primarily in the future tailgate entry in the three-entry section and across the central portion of all five entries in the yield pillar section of the experimental section. In general, the fair to poor roof quality in site 1 was most often associated with the presence of thick-shale drawrock or sandstone containing unusual amounts of shale and coal spars. The immediate roof at site 2 was almost entirely sandstone with only small amounts of thin drawrock, and roof quality was good or very good over much of the site (fig. 8). As the study progressed through each site, roof quality was recorded systematically for each instrument station, so that the location, extent, and timing of degradation could be determined with some degree of objectivity.

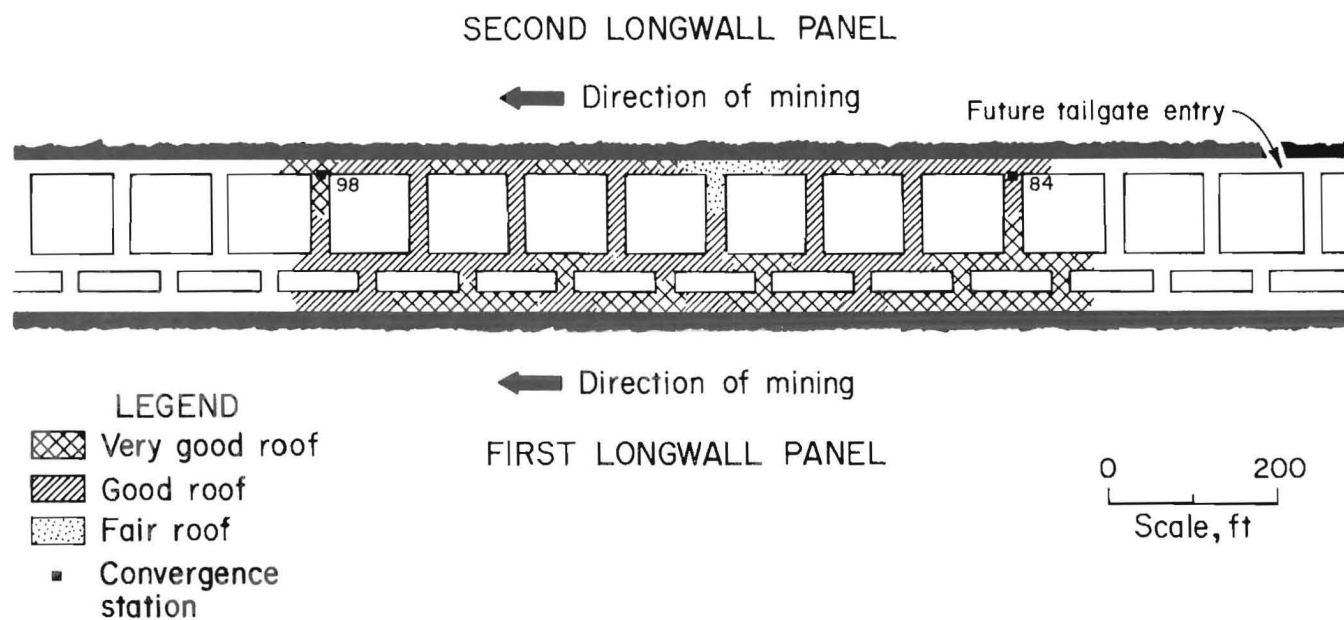
Figure 8.—Map of initial roof quality in site 2.

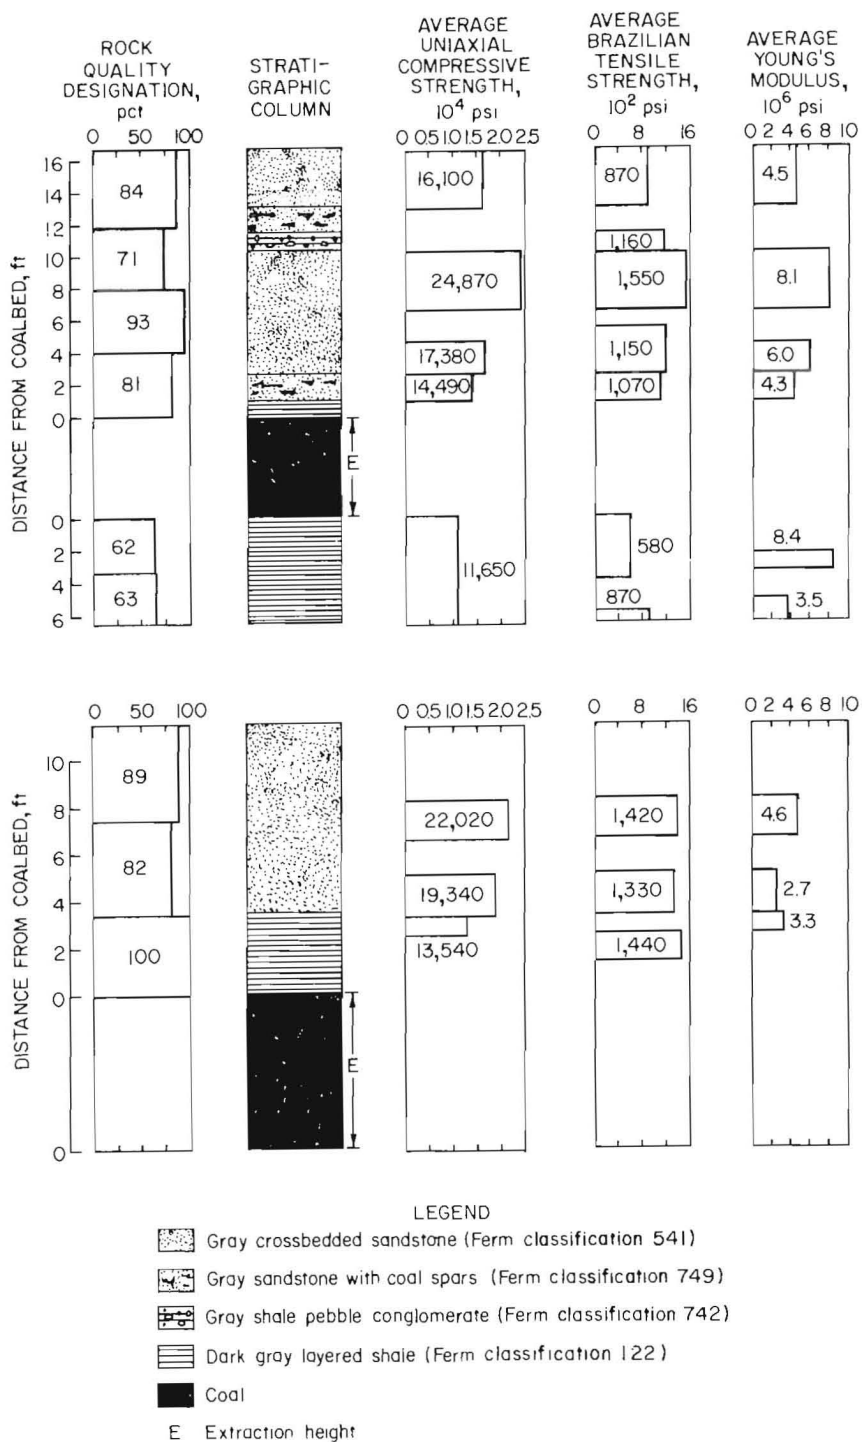
Figure 9.—Geological logs and results of laboratory strength testing obtained from core drilling in site 1. Top, diamond core site B-1; bottom, diamond core site B-2.

was a uniform shale, with a measured compressive strength in excess of 11,000 psi. No coal samples could be obtained for testing, because all of the ribs of all the pillars in the deep cover area were highly deformed and fractured. No core drilling was performed at site 2.

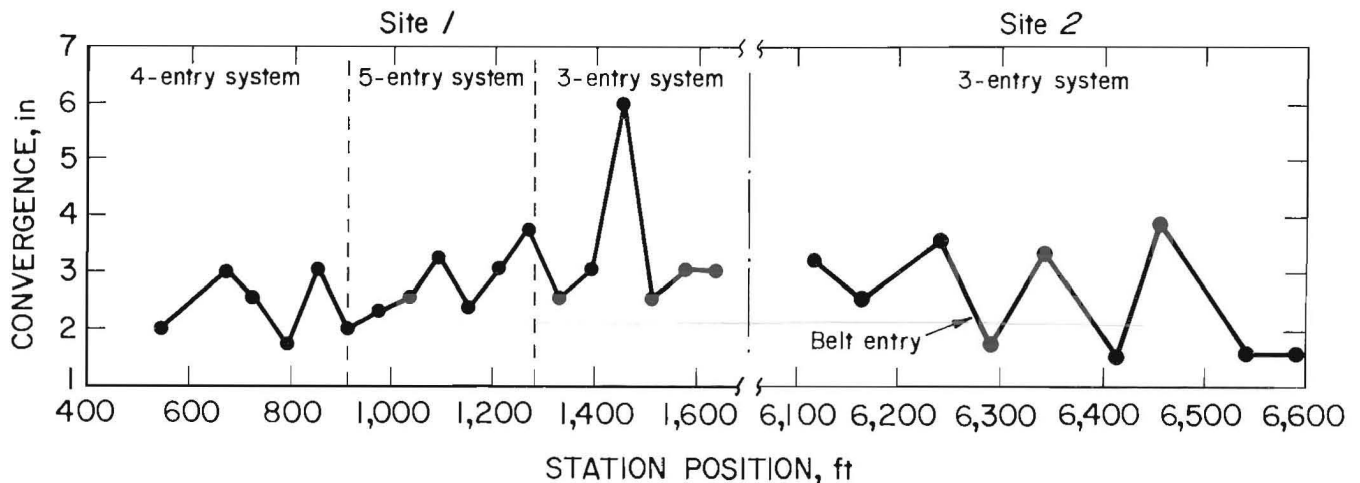
Figure 10.—Convergence measured as the face passed each convergence station in the belt entry (face distance = 0).

Figure 10 shows, except for one localized instance of floor heave in the experimental section (site 1), that

convergence in the belt entry at both sites was a consistent 1.5 to 4 in regardless of pillar design. Observations also indicated that the decline in roof quality in the belt entry, which was typically about two grades for site 1, was not affected by pillar design. The minor ground control problems that did develop in the belt entry were attributable to preexisting roof conditions. For site 2, the initial roof conditions were good and did not deteriorate as the face mined by. These observations indicated that not one of the three pillar designs performed noticeably better or worse than the others in providing ground control during the headgate phase.

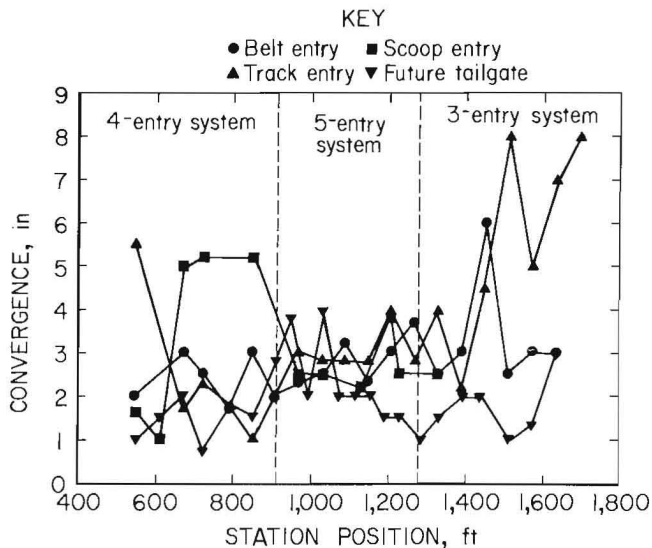
Figure 11.—Convergence measured at all stations in site 1 at face distance = 0.

Figures 11 and 12 summarize the results from all the convergence measurements at FD=0 for both study areas. Here some differences between the pillar designs do

emerge. In the abutment pillar systems, particularly the three-entry system, convergence in the future tailgate entry was significantly less than it was in the entries nearer the panel. In the yield pillar system (five-entry system), all the instrumented entries closed by about the same amount. In the five-entry yield pillar system, the abutment pressures appear to have been transferred all the way across to the solid coal of the second longwall panel, resulting in uniform entry closure.

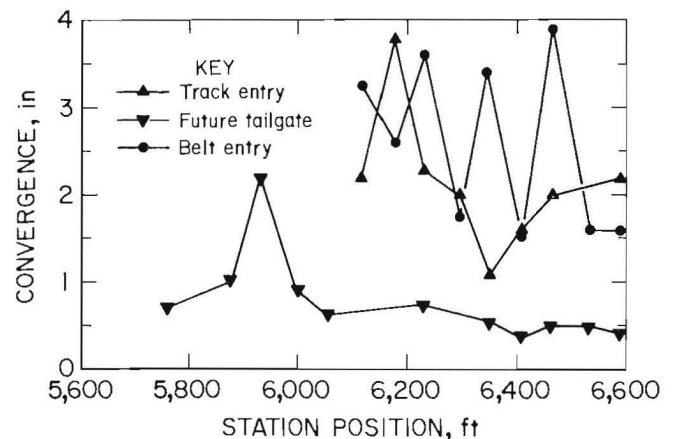
Figure 12.—Convergence measured at all stations in site 2 at face distance = 0.

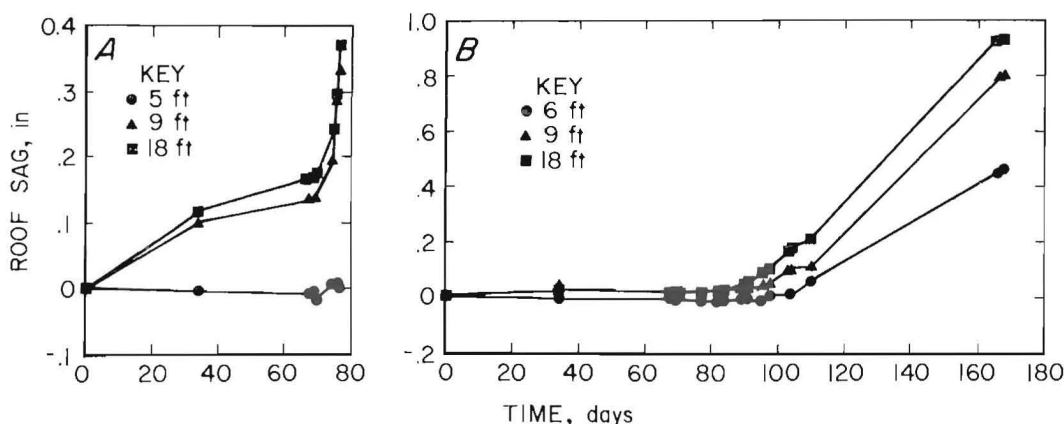
Figure 13.—Results of roof sag measurements in the track entry. A, rapid sag rate several days before failure, station 44; B, steady sag in stable roof, station 89.

Roof sag measurements made during the approach of the face in both sites typically totalled less than 0.25 in, indicating that most of the measured entry closure was due either to pillar shortening or to floor heave. In addition, in 4 of the 18 sag stations in the experimental section rapid roof sag rates were measured that apparently correlated

with the onset of roof instability. Figure 13A shows the rapid development of sag several days before the roof collapsed at station 44. In contrast, figure 13B shows data from station 89 in the future tailgate entry of site 1 that showed no sign of instability, even though nearly 1 in of total sag was measured. The rate of roof sag in site 2 was even lower than the rate shown in figure 13B indicating that the conditions in site 2 were better than any of the three pillar design areas studied at site 1; although, this rate could be due to the good initial roof quality. These measurements indicate that the rate of roof sag, rather than the magnitude, could be used to predict the approach of roof instability. Other researchers have also concluded that the rate of roof sag is a reliable means of predicting imminent roof failure (11).

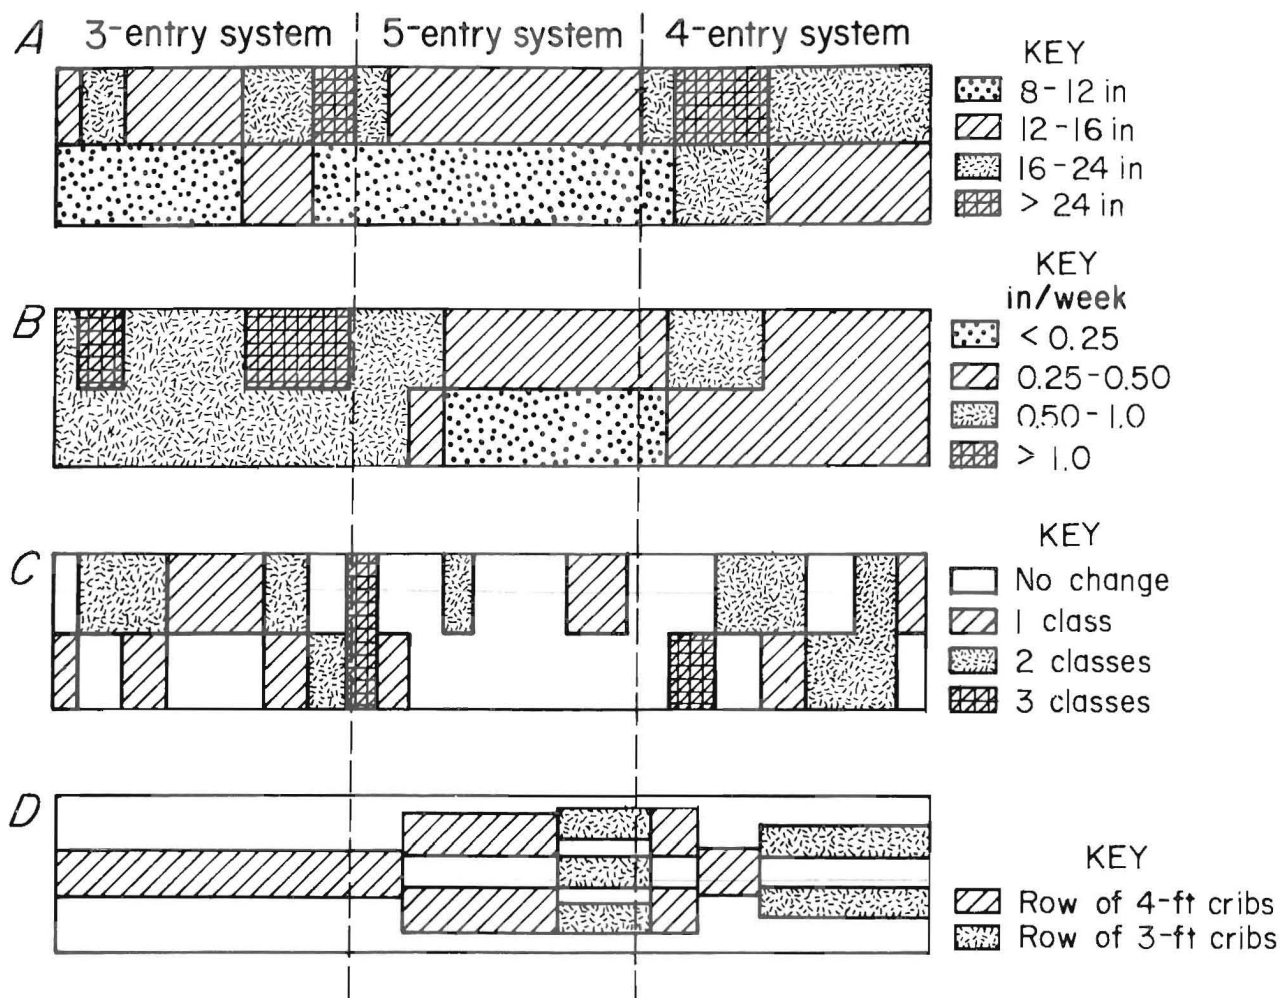
Figure 14.—Analysis of the future tailgate entry when face was 1,000 ft outby site 1. A, total entry convergence; B, entry convergence rate; C, change in roof quality; D, crib support pattern.

Figure 14 summarizes the results of the survey made in site 1 when the face was 1,000 ft outby. Significant differences between the pillar systems were apparent regarding protection of the future tailgate entry. In fact, there appeared to be five distinct zones of strata behavior, corresponding to the three pillar designs and two transition zones between designs.

The worst conditions were observed in the two transition zones, near stations 86 and 94. Total convergence near the solid rib at these stations measured in excess of 2 ft (fig. 14A), with convergence rates still much higher than in adjacent areas (fig. 14B). The roof quality had also deteriorated to the point of collapse. It appeared that the severe differential floor heave at these locations might have caused the roof damage.

The conditions in the future tailgate corresponded closely to the density of the supplemental wood cribbing that was installed (fig. 14D). Where the cribs were placed

closest together, in the five-entry system, the conditions were best. The worst conditions, outside of the transition zones, were found where only a single row of cribs were installed. The conditions were so poor in these areas that mine management decided to make a double row of 4-ft cribs the standard for the remaining length of the future tailgate.

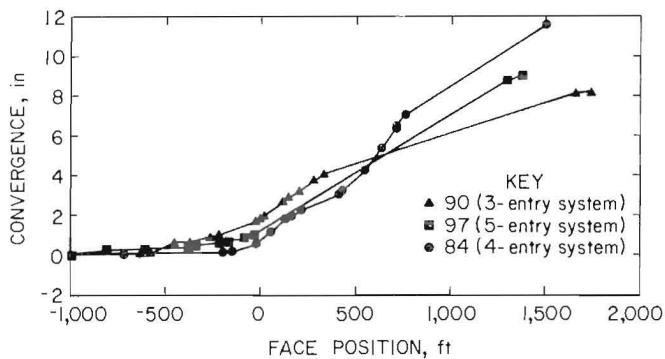
Figure 15.—Typical convergence histories from selected convergence stations from each of three pillar designs in site 1.

The timing of the convergence sheds more light on the conditions observed in the future tailgate entry. Figure 15 shows convergence histories from representative stations located in each of the three pillar designs in site 1. In the yield pillar area (station 90), convergence developed more rapidly, but leveled off earlier than in the abutment pillar areas. It is possible that the abutment loads initially caused additional shortening of the yield pillars, again stress-relieving the area and resulting in lower rates of floor heave. The abutment pillars, on the other hand, apparently retained high loads, causing higher long-term rates of floor heave.

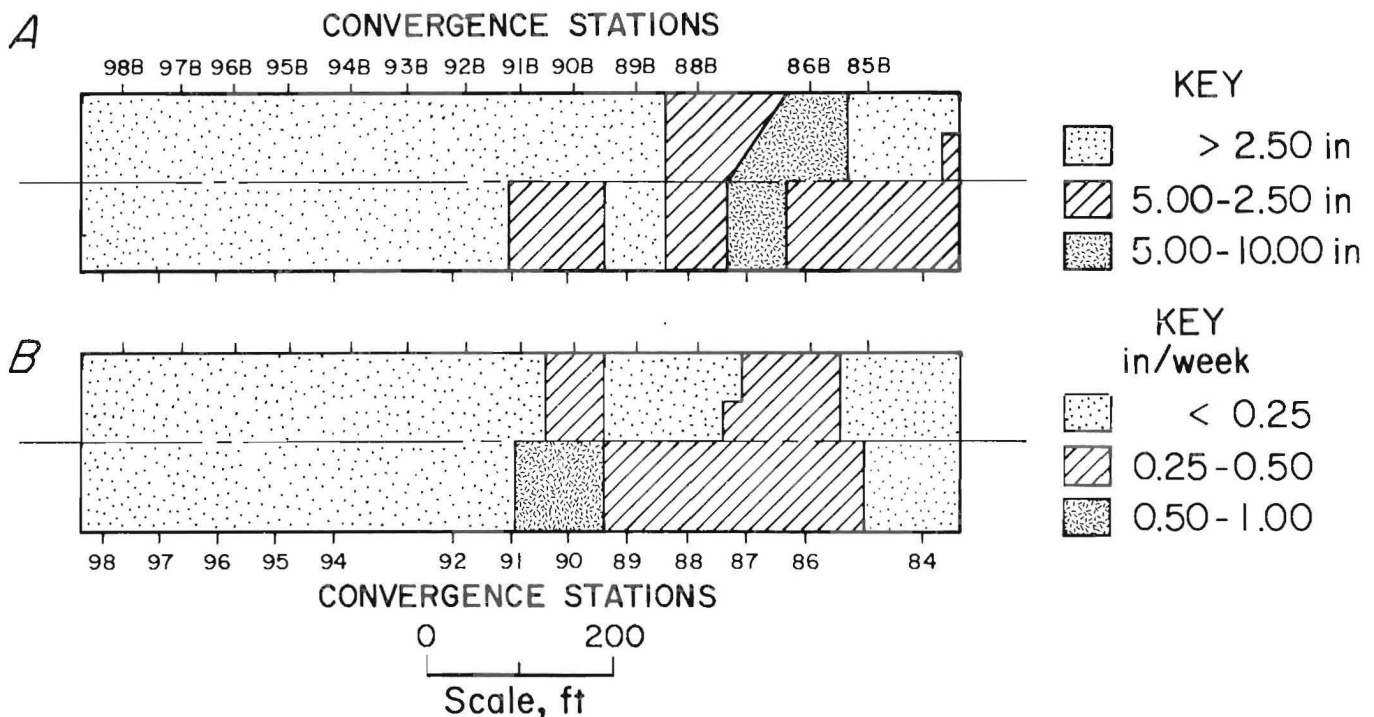
Figure 16.—Analysis of future tailgate entry when face of first panel was at its furthest point outby site 1. A, total entry convergence; B, entry convergence rate.

Ground conditions in site 2 after the face had passed were far better than had been the case in site 1. Roof quality observations, supported by the roof sag measurements, indicated that relatively little damage to the future tailgate entry had occurred due to the passage of the first face. Total convergence was also lower, and convergence rates were less than 0.25 in/week over much of site 2, considerably less than had been observed in the three-entry system of site 1 (fig. 16).
